8511 Guilford Road Private

Maryland Historical Trust Maryland Inventory of Historic Properties Form

Inventory No. HO-1087

The house at 8511 Guilford Road is located on the north side of the road just east of the intersection of Kindler Road, about 2 ½ miles south of Columbia and 1 ¾ miles southeast of Simpsonville in southern Howard County, Maryland. The house faces south toward the road and is a one-story frame rancher with a rectangular plan, and is four bays by two bays. It is banked into a hill on the south, with an exposed basement on the north. It has a gable roof with asphalt shingles and an east-west ridge. There is a parged foundation, brick veneer on the south elevation, and aluminum siding. There is an open carport on the west end, beneath the extended end of the gable roof, with a new shed built against the western end of this carport.

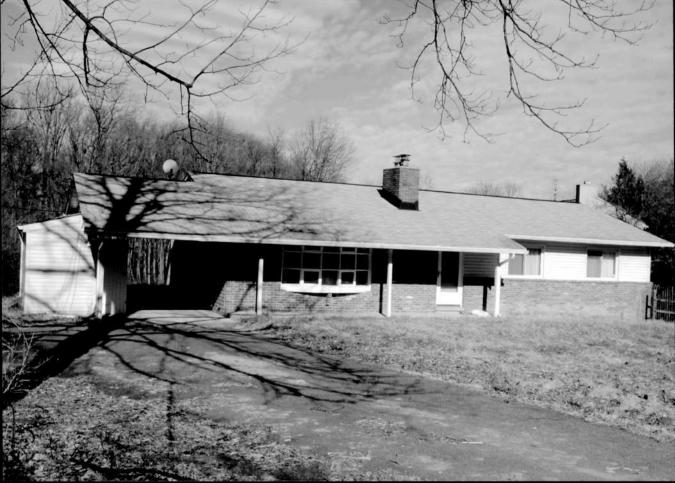
HO-1087_2012-02-27_01 South elevation

The south elevation has a segmental bow window with 20 lights in the west bay, a door in the west-center bay, and paired sliding sash in both of the eastern bays. The roof eave extends further beyond the wall on these two bays, creating a short porch, and is supported on four square wood posts. The brick veneer for the two eastern bays does not extend above the window sills. There is an interior brick chimney between the west and west-center bays, and it is set south of the ridge.

> 8511 Guilford Road Howard County, Maryland Ken Short 2012-02-27 MD SHPO south elevation 10f2

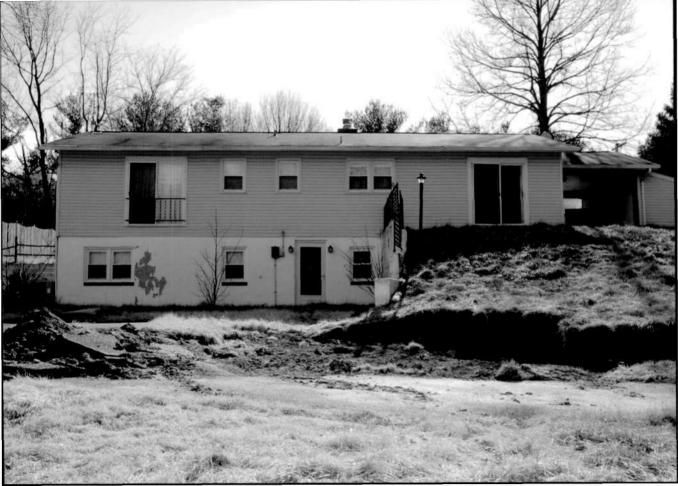
HO-1087_2012-02-27_02 North elevation

The west elevation, beneath the carport, has one-over-one sash. The basement of the north elevation has paired one-over-one sash in the east bay, a single one-over-one sash in the east-center bay, a door with nine lights over two tall panels in the west-center bay, with a one-over-one sash just west of it. All of these windows have brick sills. There is a CMU retaining wall just west of the western-most window, with the west bay of the basement set below grade. The first story east bay has sliding glass doors with an iron railing blocking it off. The east-center bay has a one-over-one sash, with an identical sash set between it and the west-center sash. There are paired one-over-one sash above the western-most basement window. The west bay has sliding glass doors. There is concrete paving to the east of the retaining wall, and it wraps around the east side.

HO-1087 8511 Guilford Road Howard County, Maryland Ken Short 2012-02-27 MD SHPO North elevation 20+2
